Important Product Safety Bulletin

Eaton/ Cutler-Hammer General Duty “B” Series Field Campaign

A potential quality issue for General Duty “B” Series Safety Switches could allow the operating handle to detach from the mechanism that operates the switch. If this occurs the handle could indicate the switch is in the “OFF” position, while the internal switch is still closed.

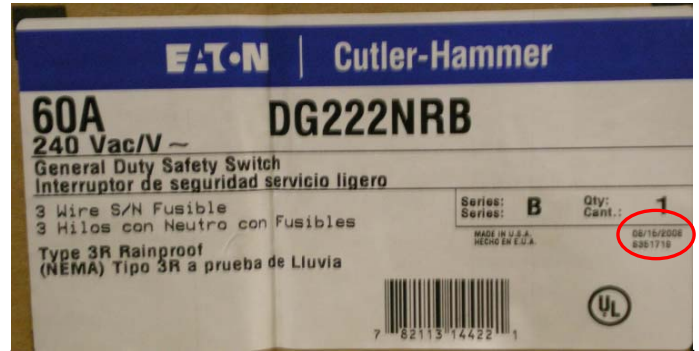
The General Duty “B” Series Safety Switches were shipped to you may have been manufactured between the date codes 8/11/2008 and 8/18/2008. The date codes for the unit or units in your possession are identified on the labels shown in Figure 2 and in Figure 3. The date code is located on both the packaging label of the box and on the inside of door of the switch. A list of affected style numbers can be found in the included table.

Figure 2. The red circles indicate where the package label date code is located.

the carton label (shown in Figure 2) or from the inside door of the unit (shown in Figure 3). If the date code is between 8/11/2008 and 8/18/2008, then you potentially have a suspect switch which Eaton will replace.

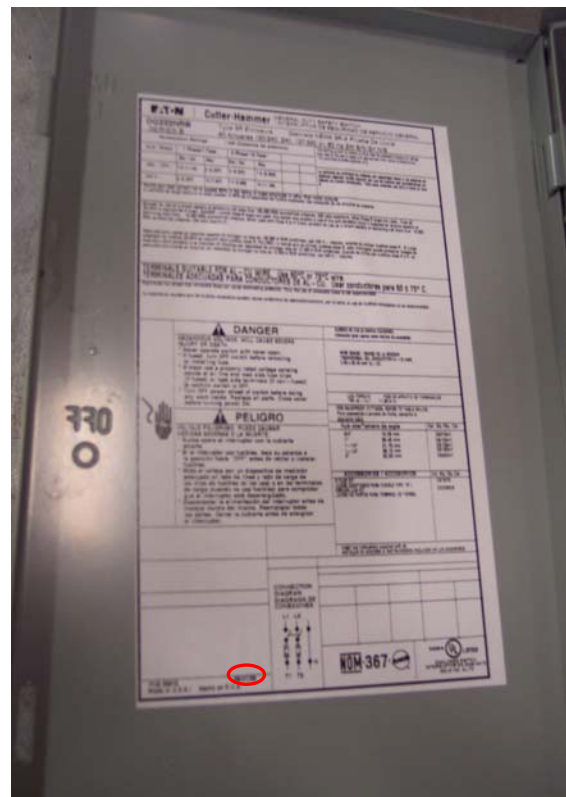
Figure 3. The red circle indicates where the date code is located on the pub inside the case of the switch
