■ SAFETY RECALL NOTICE ■

Re: *Product Recall of General Power Products 6000 Watt Portable Generators, Model # APP 6000 and Poulan Pro 6000 Watt Portable Generator, Model # PPG 6000*

OCTOBER, 2008

Instructions for Identifying and Removing Cover Plate and Inspecting Fuel Cock Valve

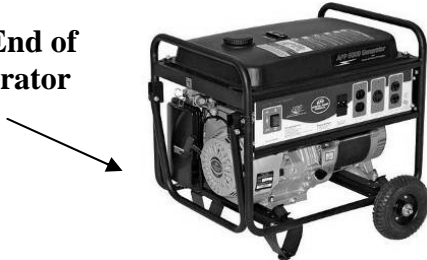
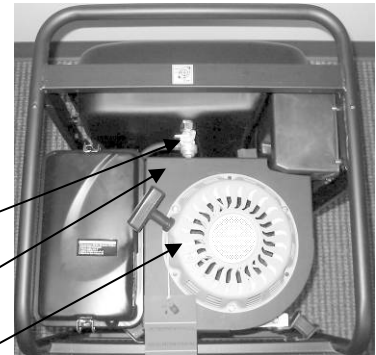
Figure 1

Model PPG 6000 and APP 6000 Generators with a Cover Plate could develop a fuel leak at the Fuel Cock Valve. To prevent the fuel leak remove the Cover Plate. The Cover Plate is non functional and is for decorative purposes only. Looking at the front control panel, the Fuel Cock Valve, Cover Plate and Pull Start are on the left end of the generator. (Fig. 1) The Fuel Cock Valve and Cover Plate may impact each other during shipping, handling and operation causing damage to the Fuel Cock Valve.

Left End of Generator

Fuel Cock Valve

Cover Plate

Pull-Start

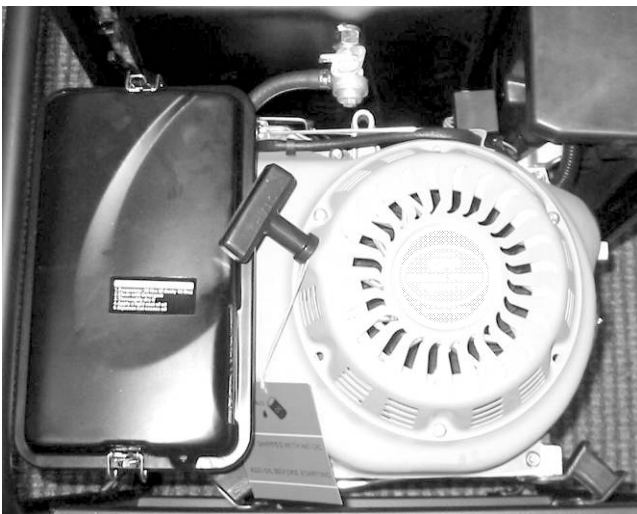
Figure 2 WITHOUT COVER PLATE

Remove Three (3) Screws

Inspect your generator as illustrated in the above photos (Fig. 2 & 3). If your generator does not have the Cover Plate, there is no need to read any further and you may continue normal use of your generator. As always, inspect the Fuel Tank, Fuel Cock, Fuel Line and Carburetor for any apparent fuel leakage prior to operating your generator.

Remove the Cover Plate by removing three (3) chrome screws which hold the Pull Start in place using a 5/16th inch or 8MM socket wrench or adjustable wrench (Fig. 3). The Pull Start assembly is 1 piece and no other parts will fall off when it is removed. The Cover Plate will easily come off after removing the Pull Start. Replace the Pull Start with the same three (3) screws. Permanently discard the cover plate. Be sure the pull start handle and the logo are oriented in the original position as shown in the photo (Fig. 2).

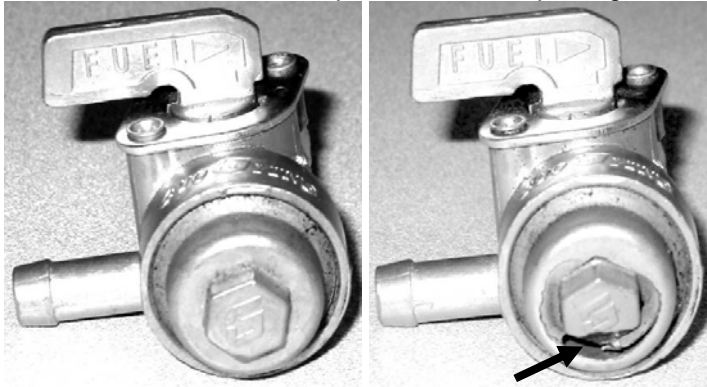
Figure 4 **NORMAL**

Figure 5 **DAMAGED**

If damage has occurred, it will be obvious and apparent. The 2 photos (Fig. 4 & 5) show both a normal Fuel Cock Valve and an example of a damaged Fuel Cock Valve.

If the Fuel Cock Valve is damaged and you have already added fuel to the fuel tank or smell or see leaking fuel, **DO NOT ATTEMPT TO USE THE GENERATOR** and call toll-free 1-877-428-3769 for repair options.

If the Fuel Cock Valve appears damaged **DO NOT ADD FUEL TO THE FUEL TANK AND DISCONTINUE OPERATION OF THE GENERATOR** and call toll-free 1-877-428-3769 for repair options.

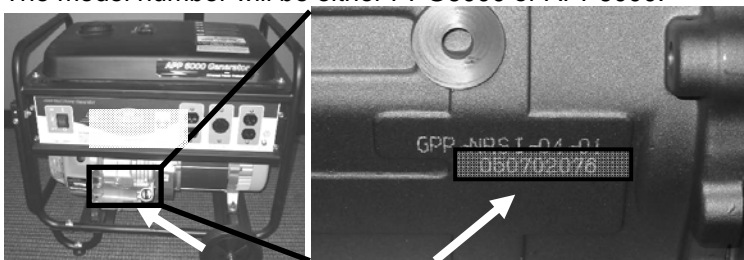
The serial number is engraved on the engine block in the location pictured above. It is the 9-digit number on the second line of the engraved information.
